Manhole Inspection Summary

Manhole # S21MM1004MH

Insp Date: **11/20/06 8:16 AM**

Location Address: **4446 LAPLATA AVE**

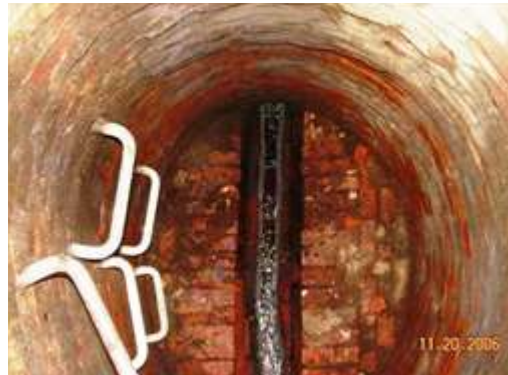
Top View

Evidence of surcharge - Bench debris.

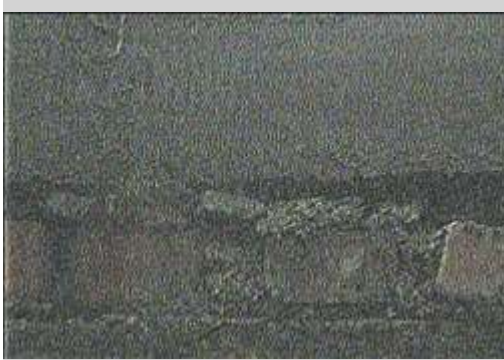
Defect

Frame Offset: **1** (in.) Condition: ☐ Sound ☐ Cracked ☒ **Leaks**

Condition: ☐ Sound ☐ Cracked ☐ Root Intrusion ☒ **Loose Brick** ☒ **Deteriorated**

Infiltration: ☐ None ☒ **Joint** ☐ Cracks ☐ Mortar ☐ Roots ☐ Wall

Frame leaks. Adjustment deterioration and loose brick. Adjustment infiltration.

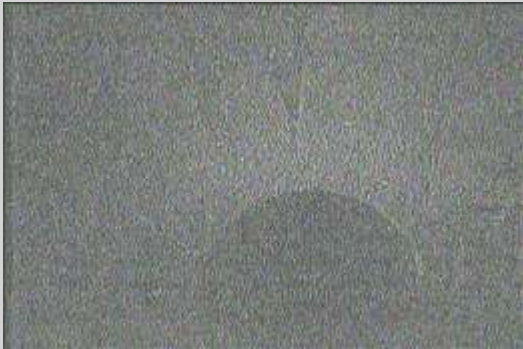
8 in. Circular Gravity Sewer Pipe Out @ 12 O'Clock

Invert Depth: **9.80** (ft.) Flow Characteristics: **Slow**

Deposits: ☒ None ☐ Mud ☐ Sludge ☐ Debris ☐ Grease

Infiltration: **None** Pipe Seal Cond: **Unknown**

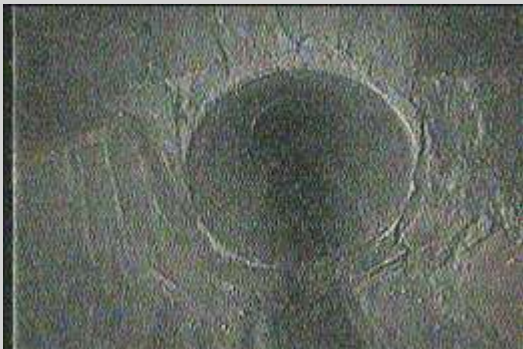
8 in. Circular Gravity Sewer Pipe In @ 6 O'Clock

Invert Depth: **9.25** (ft.) Flow Characteristics: **Slow**

Deposits: ☒ None ☐ Mud ☐ Sludge ☐ Debris ☐ Grease

Infiltration: **None** Pipe Seal Cond: **Unknown**
